Corrosion in the Petroleum Industry

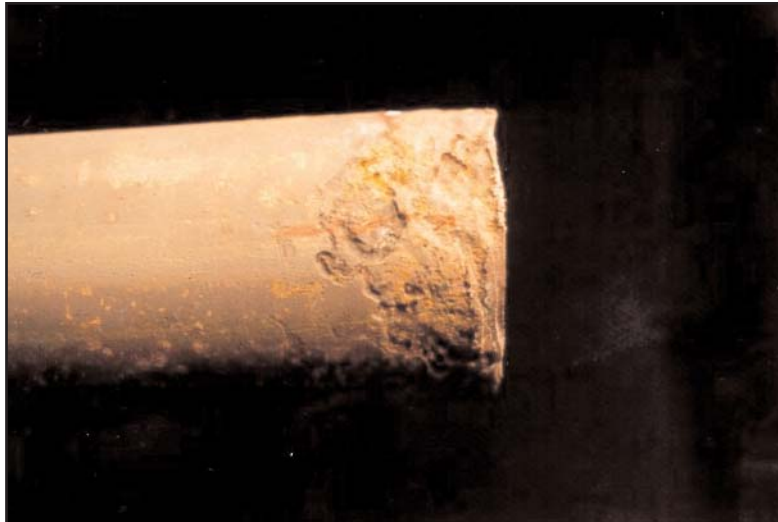
Carbon dioxide (CO_2) is absorbed in brines and can cause severe corrosive attack of steel. The corrosion rates of CO_2 can theoretically be from 1,000 to 10,000 mils per year, if not stopped by corrosion products or inhibitors. Uniform corrosion takes the form of hills and valleys with very little area that is not attacked (Figure I-1).

Figure I-1: Uniform Corrosion

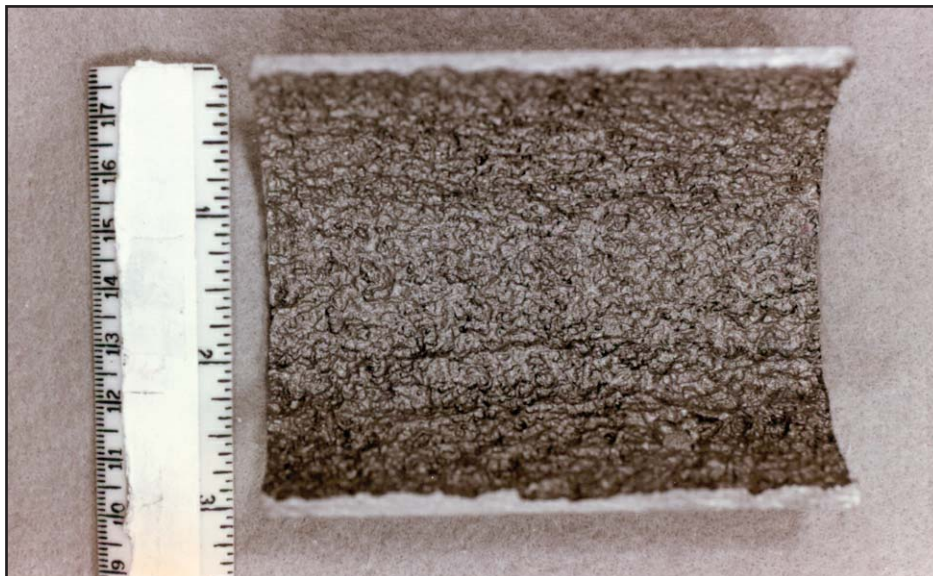
An example of uniform CO_2 corrosion from tubing is shown in Figure I-2.

Figure I-2: Uniform Corrosion in Tubing

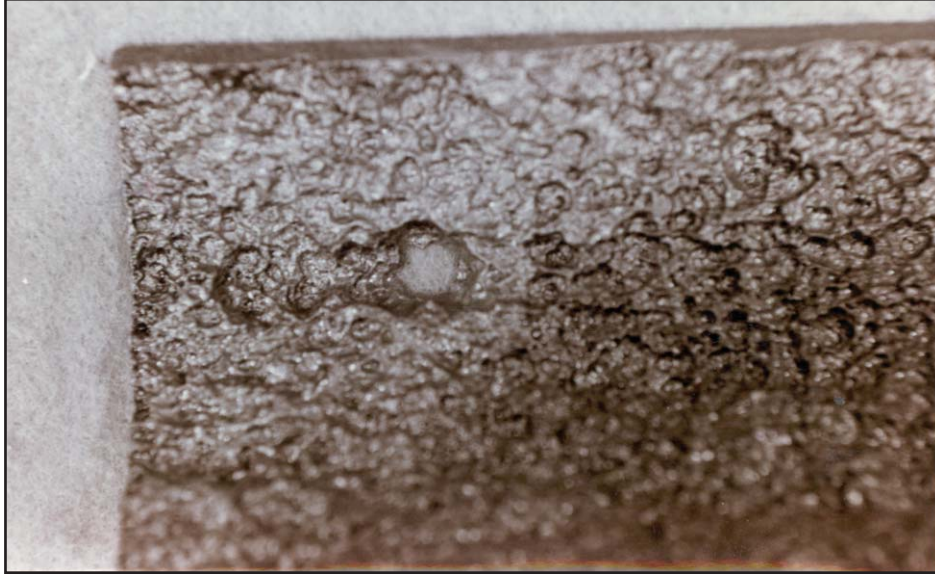
Another form of CO₂ corrosion takes the form of numerous pits (Figure I-3).

Figure I-3: Uniform Corrosion with Numerous Pits

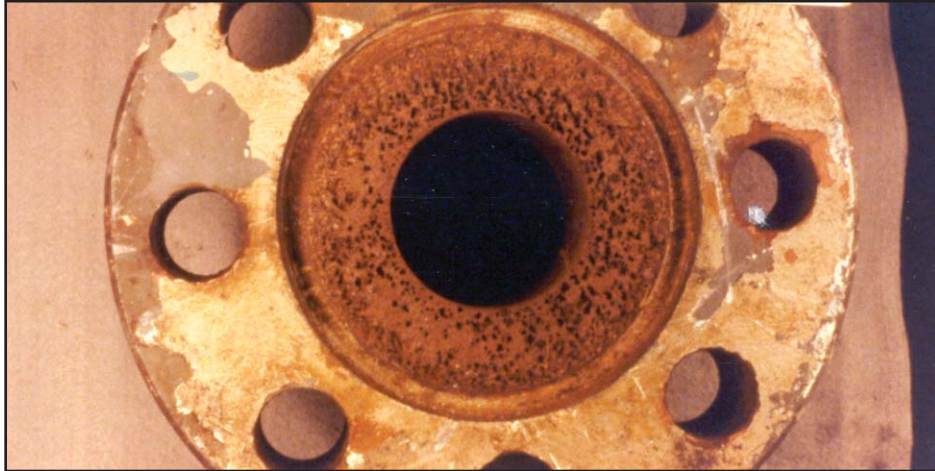
Another form of CO₂ attack has been observed on exposed faces of high-pressure wells, taking the form of an intricate honeycomb (Figure I-6 and Figure I-7).

Figure I-7: CO₂ Attack — Honeycomb Pattern

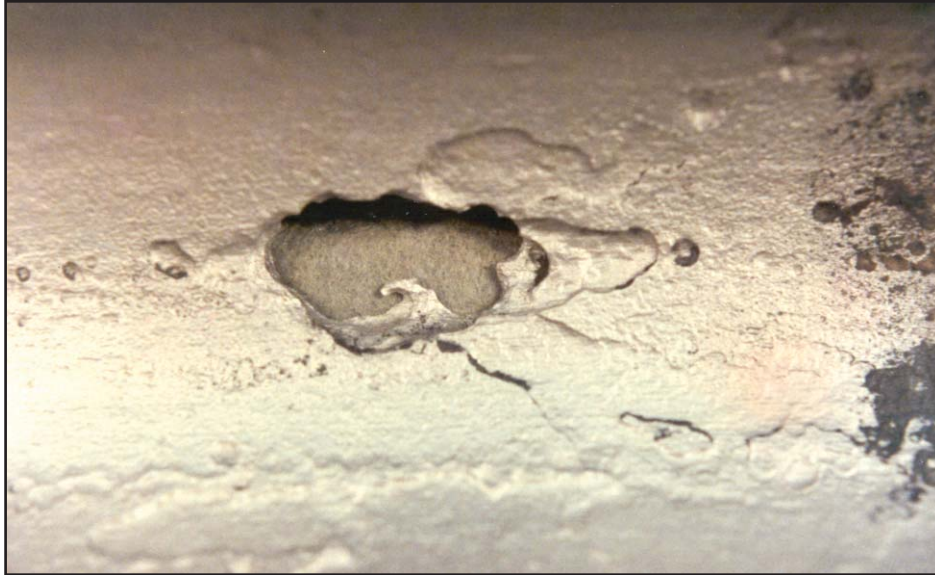
A piece of downhole tubing that perforated within two years of operation is shown in Figure I-10 and Figure I-11.

Figure I-11: Tubing Perforated by CO₂ Corrosion

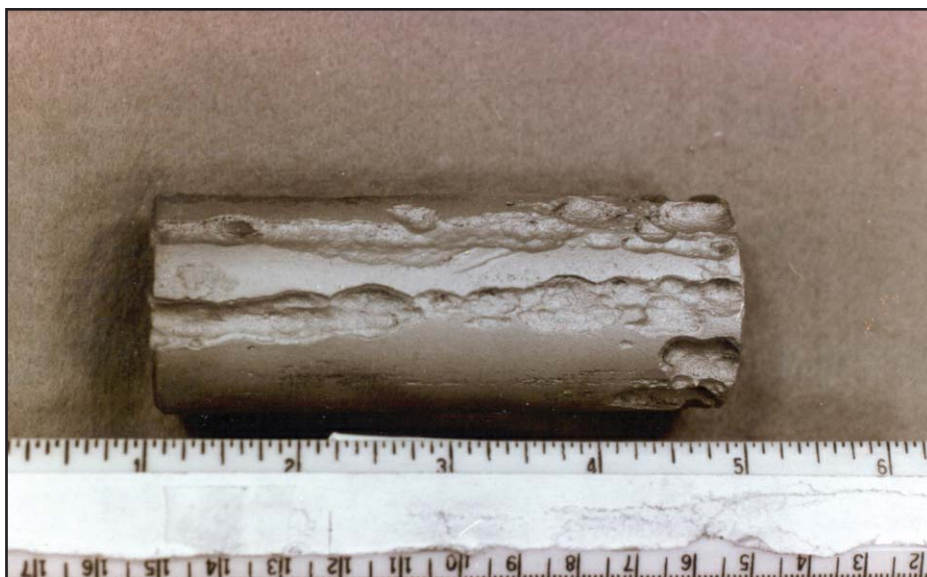
In the wormhole attack, individual CO₂ pits are interconnected and form a wormhole appearance, with segments very similar to the segmentation pattern on a worm. A sucker rod connector had a typical wormhole (Figure I-13).

Figure I-13: Sucker Rod Connector with Wormhole

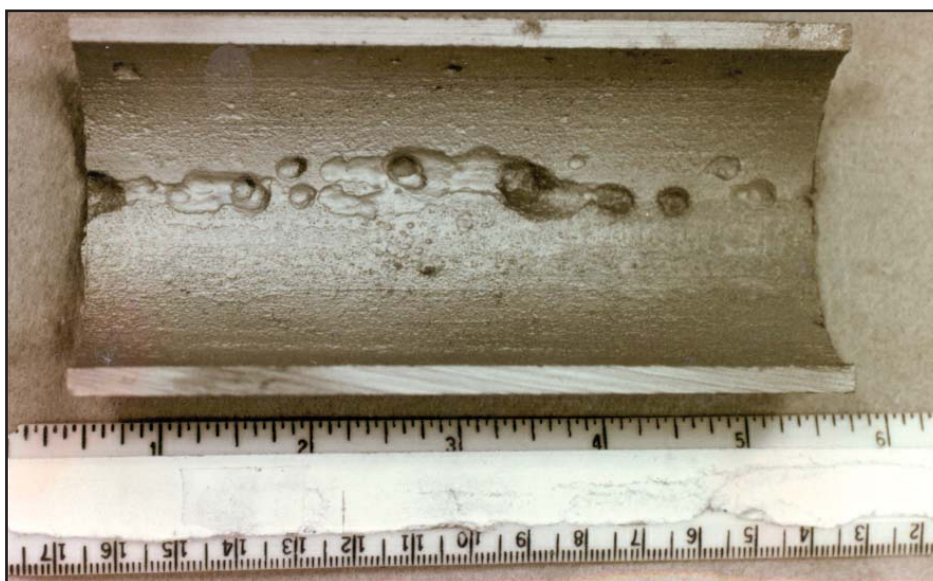
Tubing with wormhole attack can be seen in Figure I-14, with a close-up view in Figure I-15.

Figure I-14: Tubing with Wormhole Attack

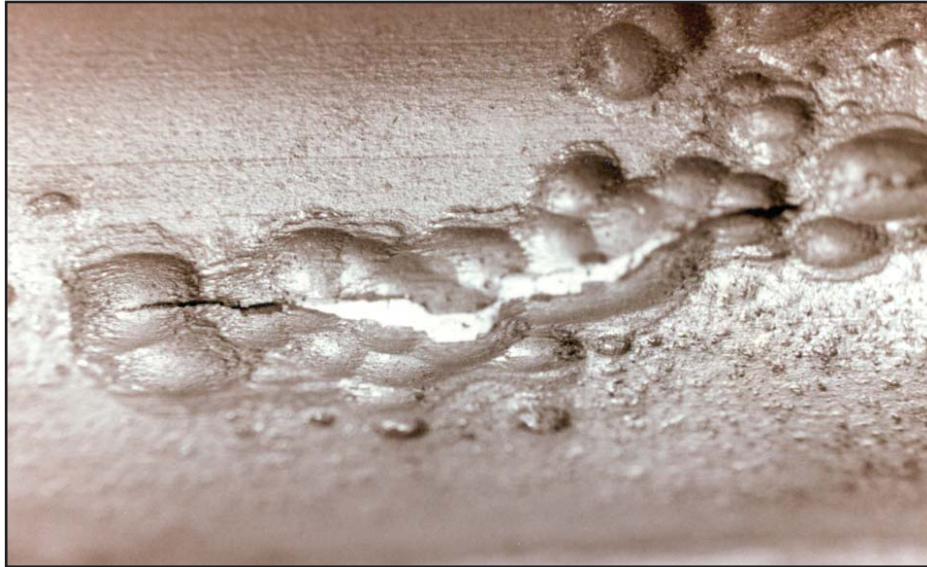
Figure I-15: Close-up Tubing with Wormhole Attack

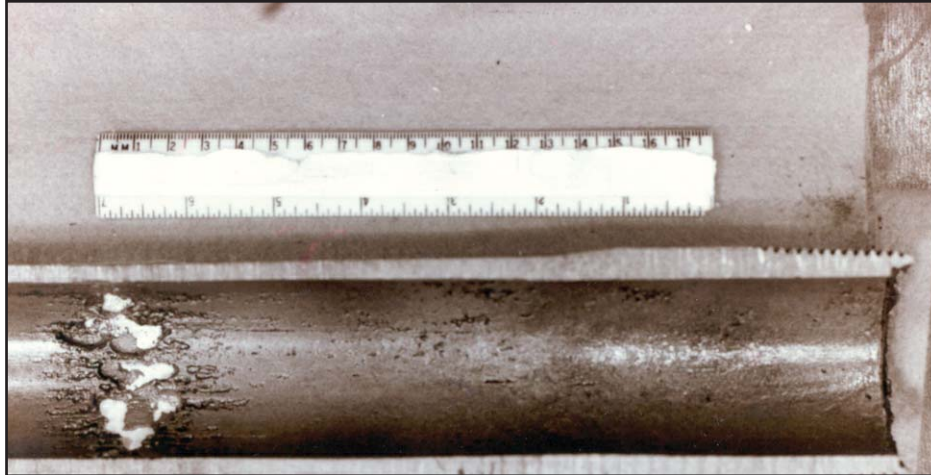
Figure I-17: Ringworm Corrosion

Ringworm corrosion is a metallurgical effect caused by the making of the upset. In fabricating the upset, a zone is created 4 to 6 inches from the upset shoulder, wherein carbon particles have been spheroidized. These spheroidal-shaped particles accelerate corrosion in mildly corrosive or even non-corrosive environments. This is a galvanic effect. If one observes numerous through-the-wall penetrations in tubing 4 to 6 inches from the upset shoulders such as in Figure I-18, ringworm corrosion is suspected.

The treatment for ringworm corrosion is to normalize the steel after making the upset. Normalizing redissolves the carbide particles eliminating the zone created by making the upset.

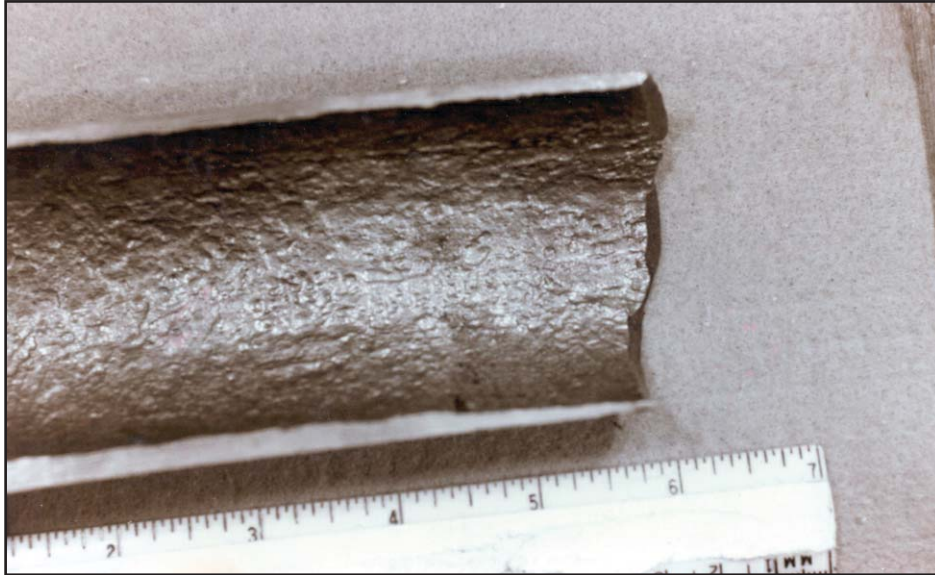
Ringworm can cause tubing parting (Figure I-19).

Figure I-19: Parted Tubing by Ringworm Attack

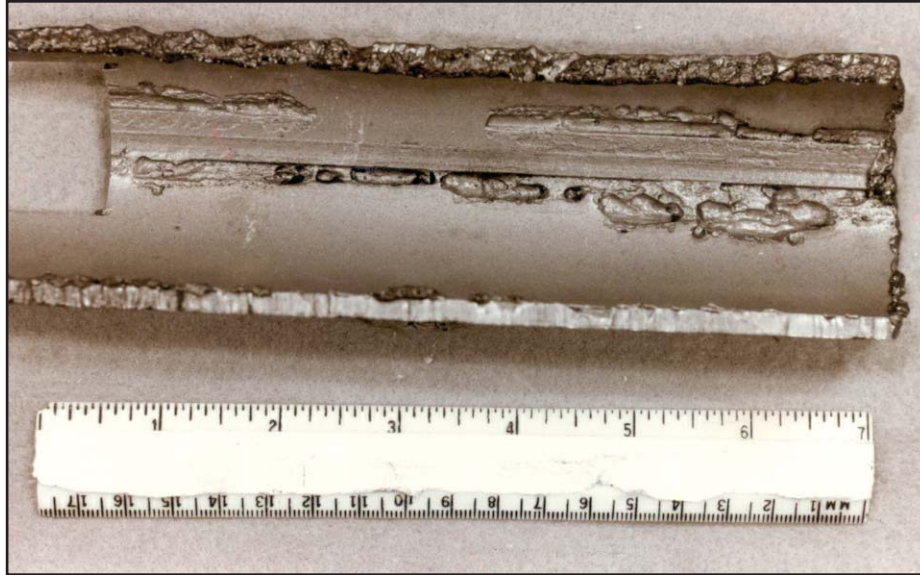
Another form of galvanically accelerated corrosion is called heat-affected zone corrosion (Figure I-21).

Figure I-21: Heat-affected Zone Corrosion

Heat-affected zone corrosion is found in elbows, reducers, and flowline tees. These are typically field welds, where there are no means of negating the effect of welding by post weld heat treatments. The fix for heat-affected zone corrosion is to normalize the steel after welding, which can be done on tubing, but may not be possible on field welds.

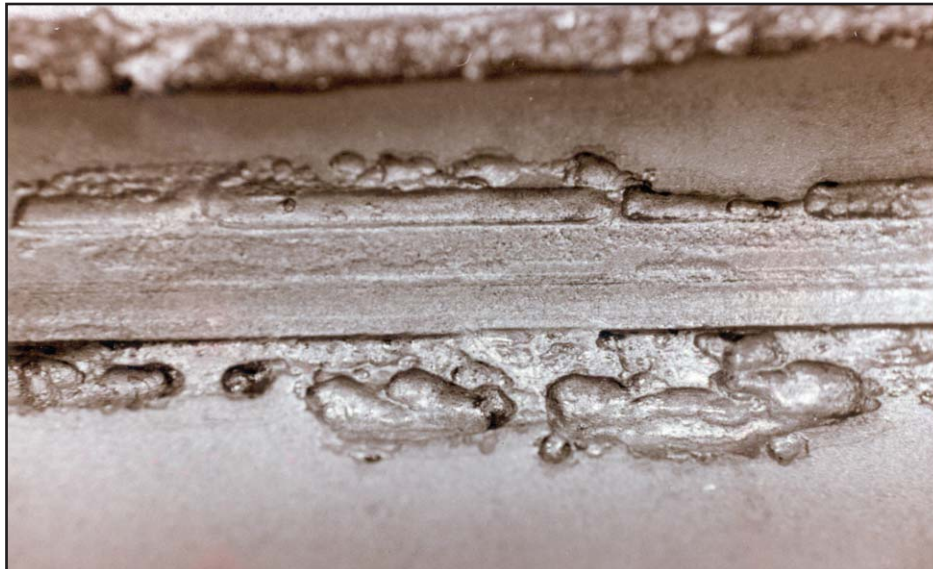
Heat-affected zone corrosion or HAZ attack is typified by deep corrosion along the weld seam. Figure I-22 shows a typical example and Figure I-23 illustrates a close-up view.

Figure I-22: HAZ as Typified by Deep Corrosion Along Weld Seam

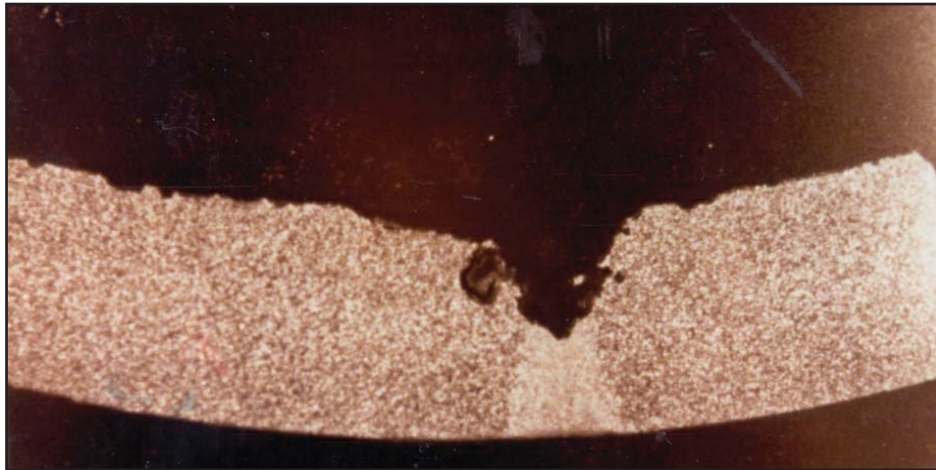
The HAZ corrosion mechanism is similar to ringworm corrosion. During welding, a zone is created wherein carbon particles accumulate and precipitate to form nodules. These nodules in mildly corrosive environments form a galvanic cell. The weld itself can preferentially corrode at times (Figure I-25).

Figure I-25: Corroded Weld

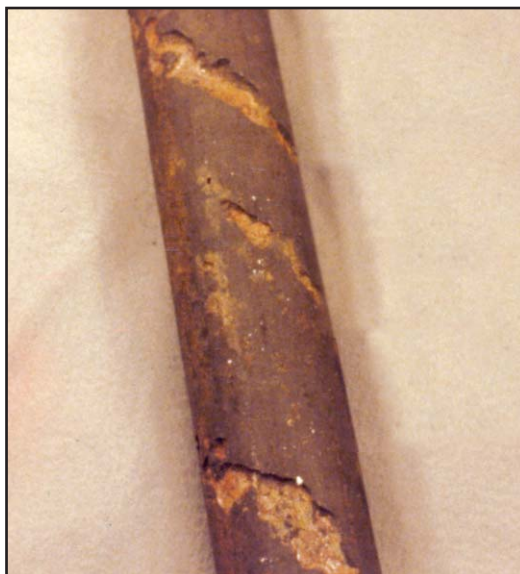
Figure I-26: Corrosion Resulting from Rolled-in Inclusions

An unusual form of metallurgical attack on the outside of tubing is shown in Figure I-26 and I-27, and is attributed to rolled-in inclusions.

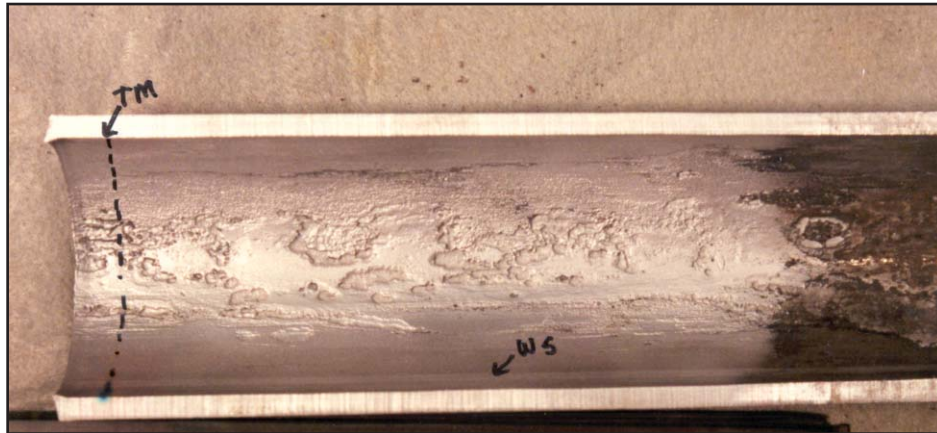
Tubing that has undergone mesa attack can be seen in Figure I-29. Flat surfaces and deep gouges between the flat surfaces typify it (Figure I-30). Mesa corrosion can be controlled with inhibitor films to get greater protection on those surfaces where corrosion has occurred.

Figure I-29: Mesa Attack on Tubing

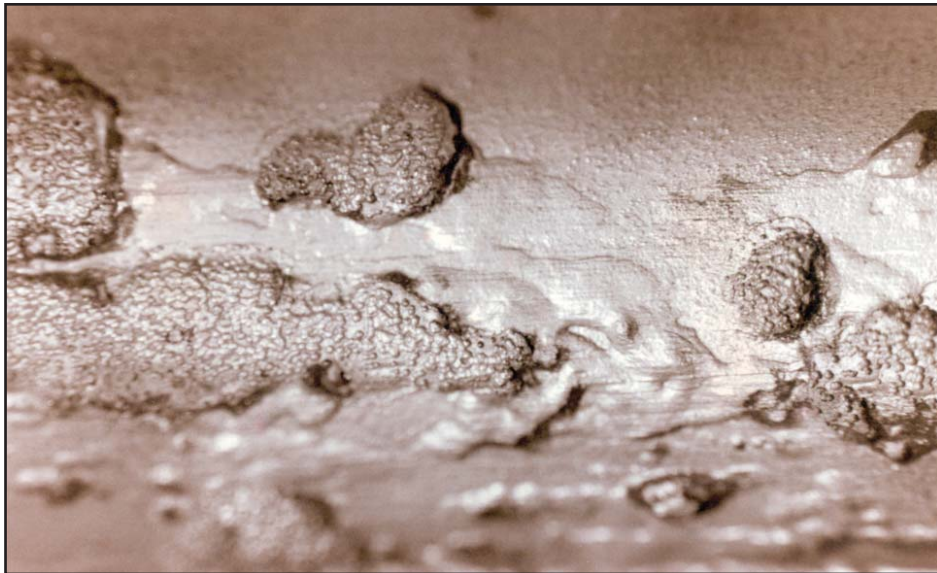
Figure I-30: Mesa Attack — Note Deep Gouges

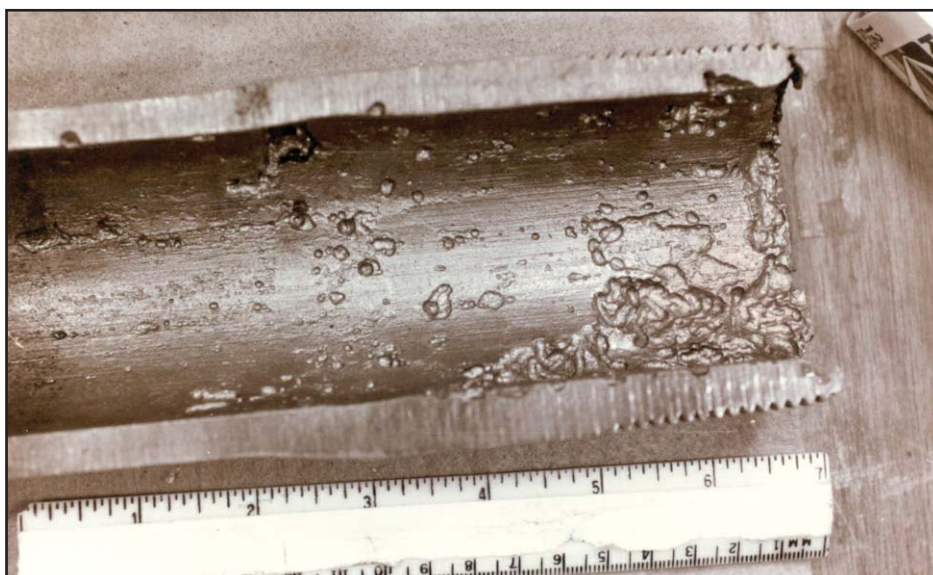
Other examples of the raindrop effect are shown in Figure I-34, Figure I-35, and Figure I-36. Use of corrosion inhibitor films might prevent the raindrop effect by preventing droplets from hanging up in the tubing. The most prevalent place for the raindrop effect has been relatively close to the Christmas tree head. However, the effect has also occurred at lower levels where the temperature is low enough to condense the moisture from the gas stream.

Figure I-34: Example of the Raindrop Effect

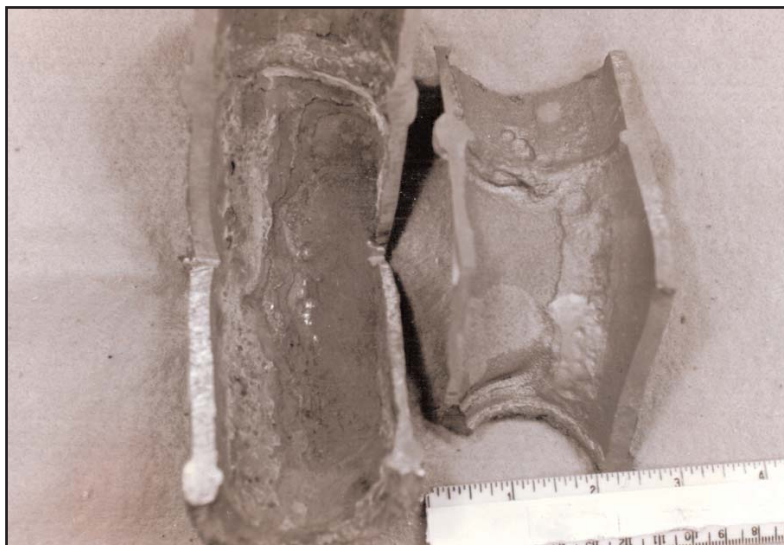
Flow-enhanced corrosion was at one time called erosion-corrosion. Flow-enhanced corrosion usually occurs when a change of direction in the flow of fluids occurs, such as near an elbow. Typically, the mechanism follows a deposition of a protective FeCO_3 film with rubbing off the film by the flow of fluids, and sometimes solids. After the protective coating is abraded off, a new surface is exposed which then immediately starts to corrode. The corrosion product is a softer surface, which is then eroded away, and the process continues until a failure occurs. The following illustrates an elbow taken from a flowline (Figure I-38).

Figure I-38: Flow-Enhanced Corrosion in an Elbow

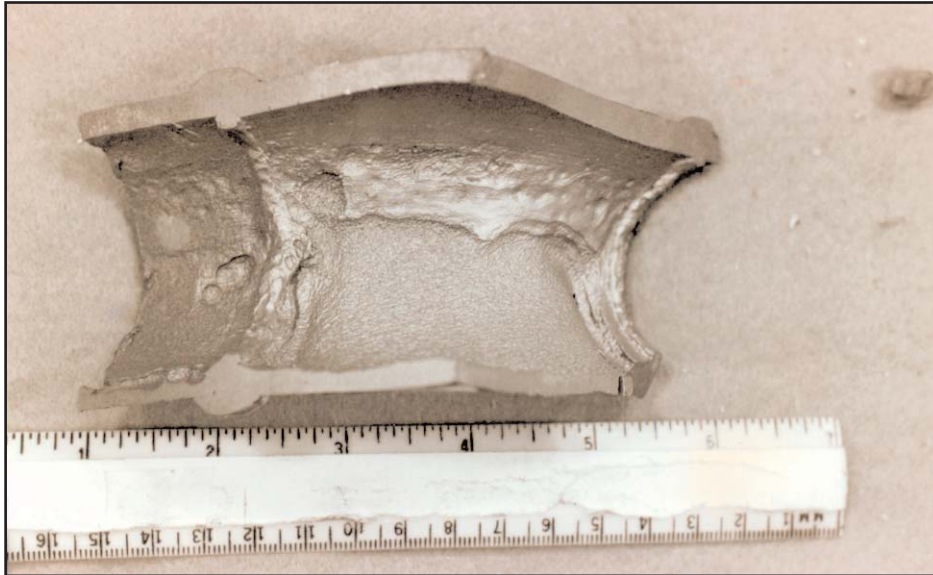
Figure I-39, a close-up view after cleaning, shows the severe metal loss. Figure I-40 shows the through-the-wall penetration.

Figure I-39: Close-up Showing Severe Metal Loss

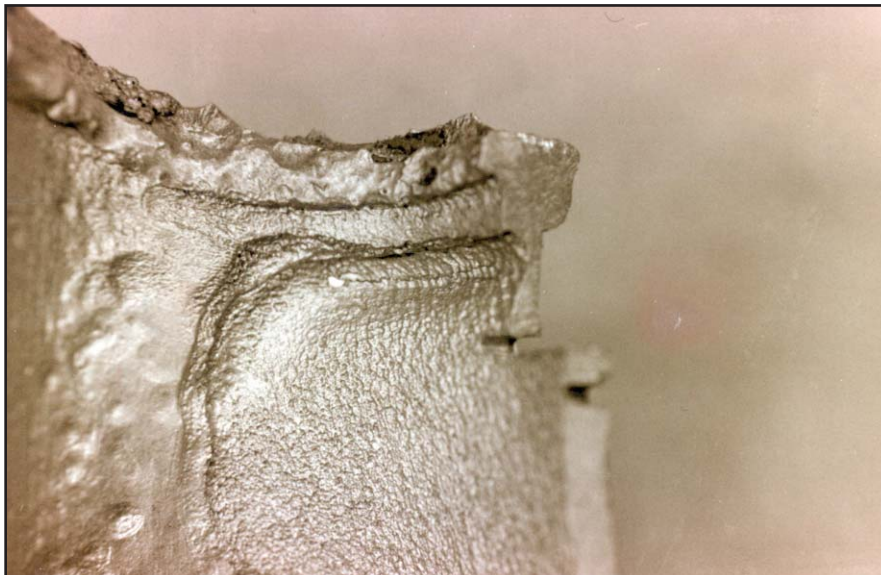
Figure I-40: Close-up Showing Penetration

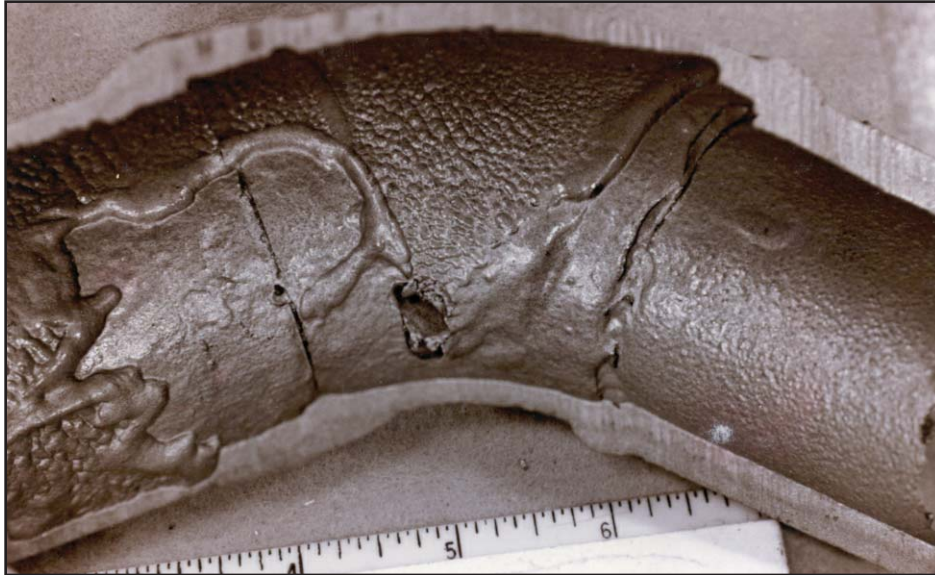
In Figure I-41, this flowline has an unusual failure mode. It is a combination of flow-enhanced corrosion and heat-affected zone attack.

Figure I-41: Combination of Corrosion Mechanisms

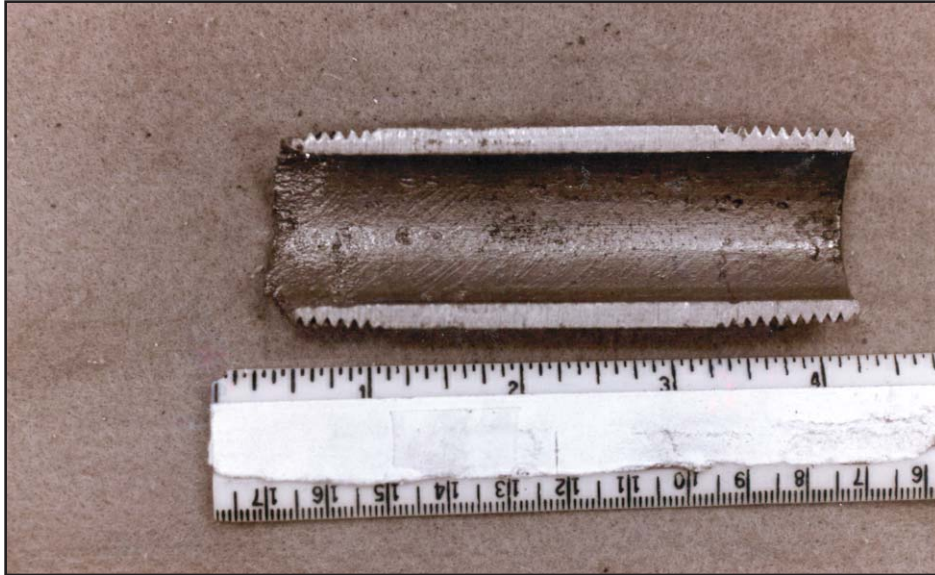
Another form of flow-enhanced corrosion is at nipple joints. Usually there is a gap when a threaded joint is made up, and at the gap, turbulence is generated and flow-enhanced corrosion can occur (Figure I-44 and Figure I-45).

Figure I-45: Flow-Enhanced Corrosion at Nipple Joints

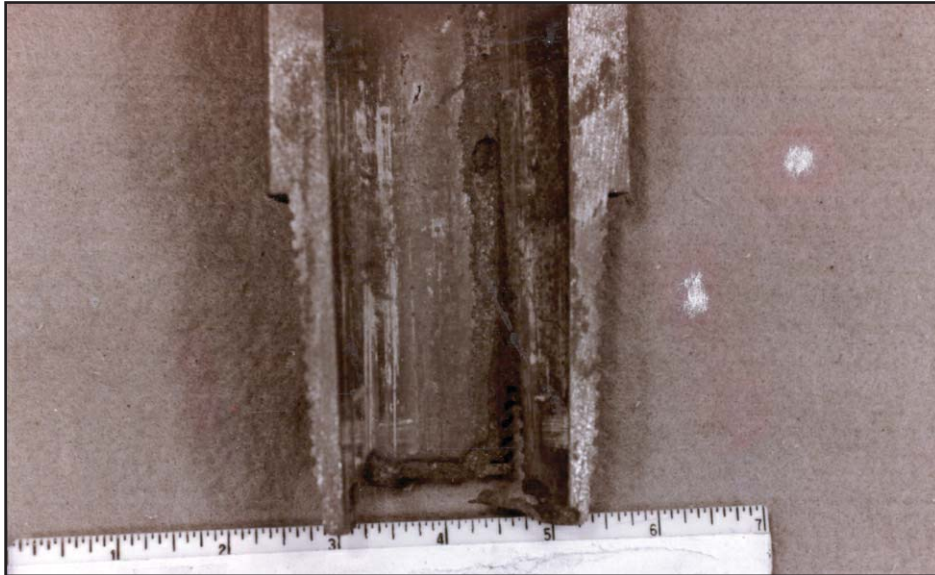
On coated tubing, wireline operations can sometimes cut the protective coating, resulting in corrosive attack where the breaks occur (Figure I-47 and Figure I-48). This attack is termed wireline attack.

Figure I-47: Wireline Attack

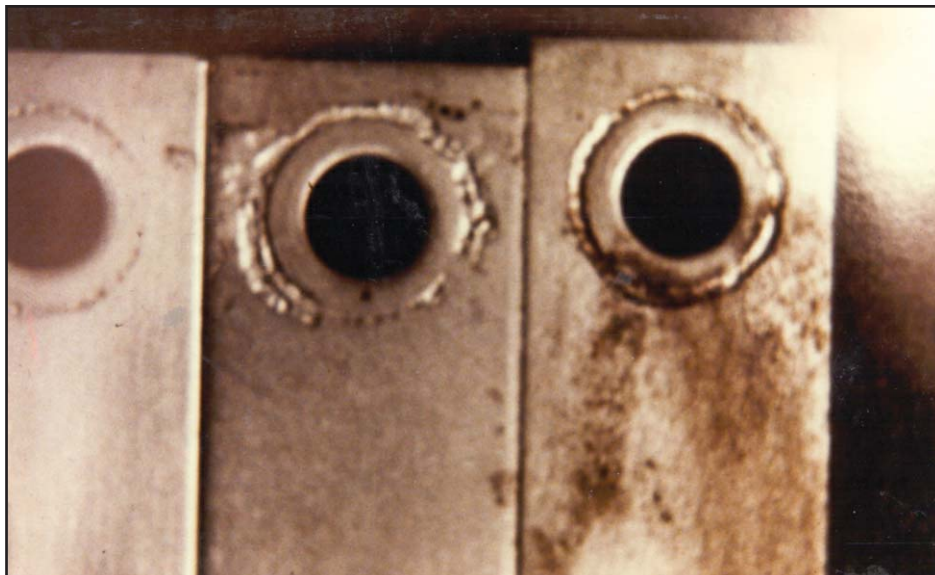
Another form of attack is called crevice corrosion. Crevice corrosion usually occurs in metals with a good protective coating. However, at crevices, there are places where the protective coating does not get underneath, and severe localized corrosion can occur (Figure I-50 and Figure I-51).

Figure I-50: Crevice Corrosion

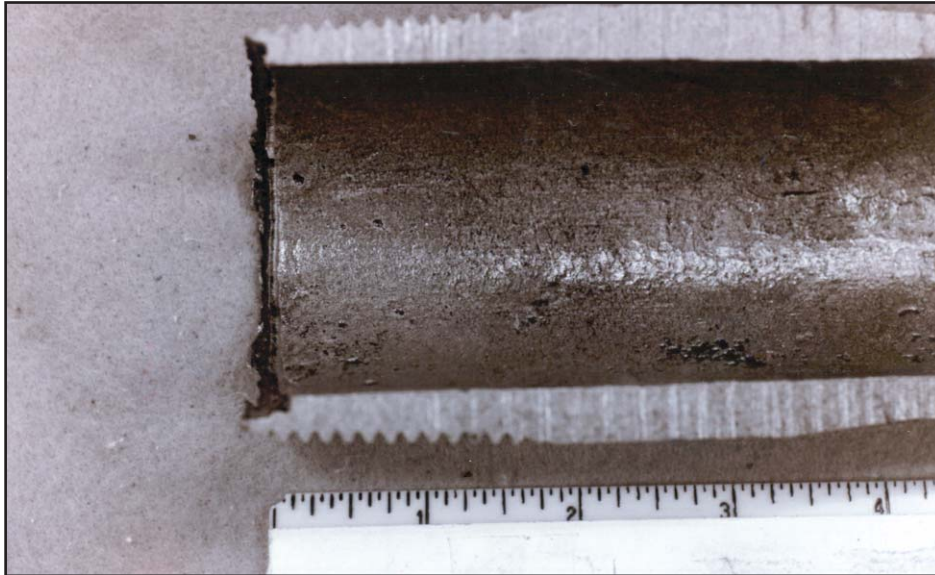
Figure I-51: Crevice Corrosion

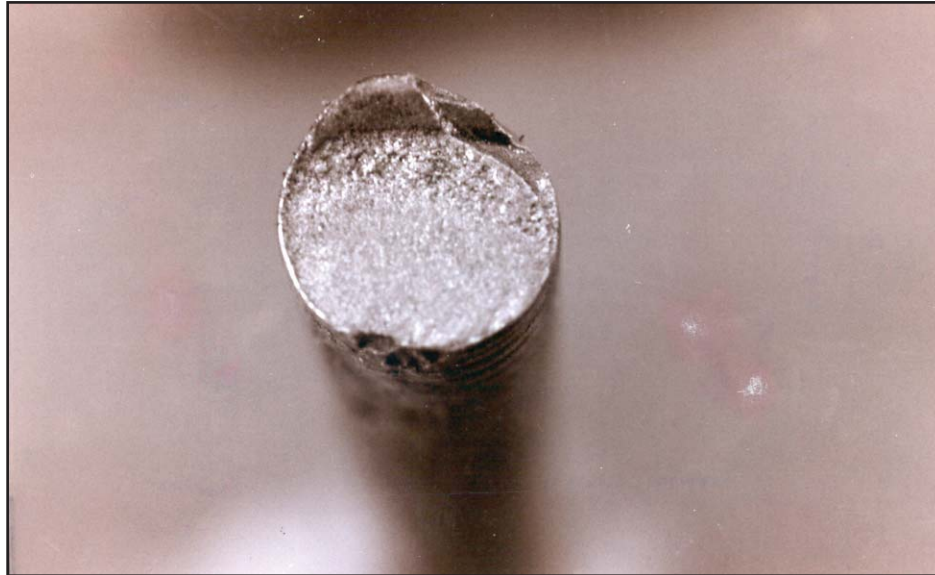
Figure I-53: Corrosion Fatigue in Sucker Rods

This failure has all the attributes of a corrosion fatigue failure, with an initiation point, a smooth half moon thumbnail, a crystalline area, and a lip break (Figure I-53).

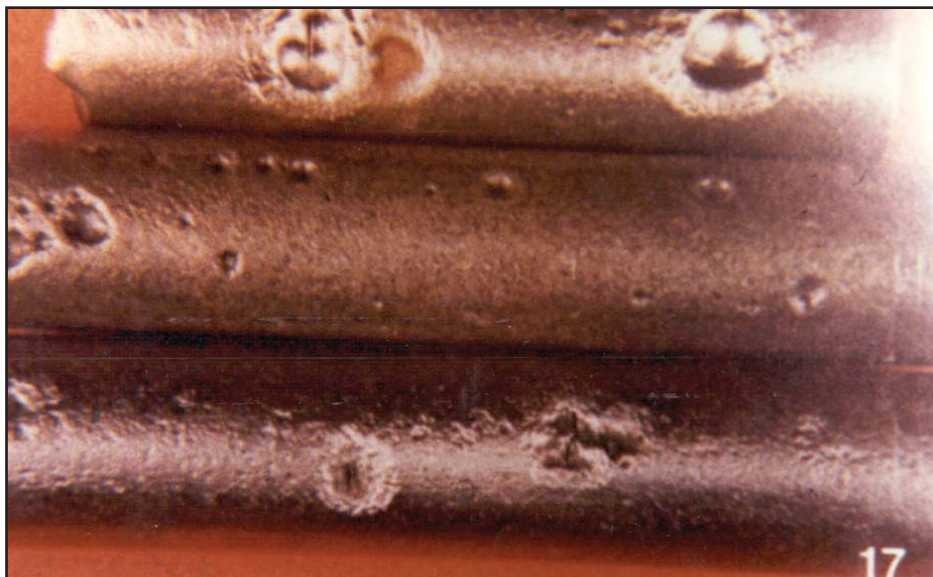
Figure III-1: Hydrogen Sulfide (H_2S) Corrosion

Hydrogen sulfide (H_2S) in produced brines generates hydrogen ions and HS ions. The hydrogen ions, being acidic, attack steel. H_2S corrosion is typified by pitting, which takes the form of shallow round depressions with etched bottoms (Figure III-1).

In addition, the sides of the pits are sloped. A quick test to detect H_2S corrosion is to test the fluids for H_2S . A few drops of hydrochloric acid with arsenious oxide on the surface deposits turns yellow if FeS_2 is present.

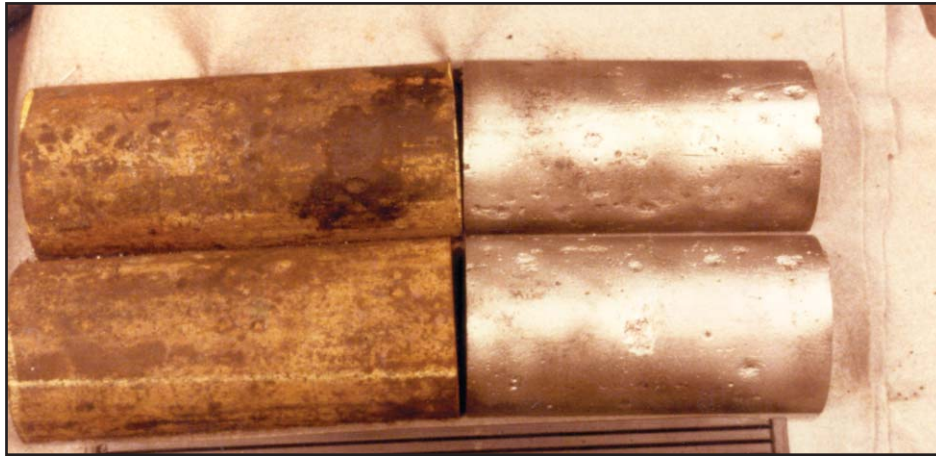
Figure III-3: FeS Crystals

Also associated with H_2S attack are some crystals of FeS_2 (Figure III-3).

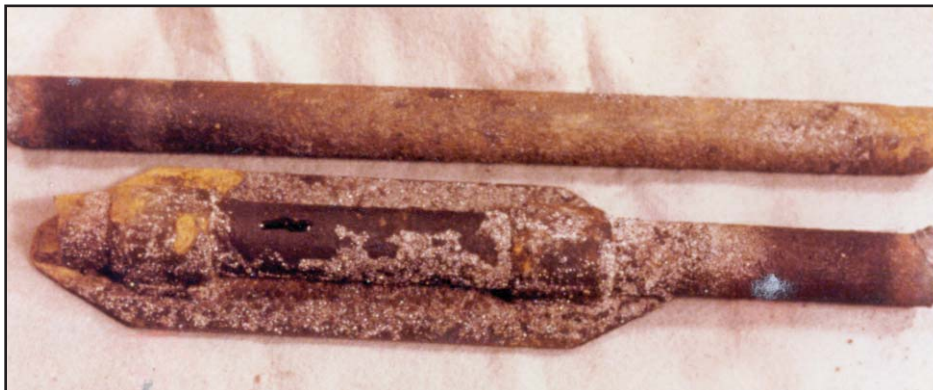
Figure III-4: H₂S Attack on Sucker Rods

H₂S attack on sucker rods can cause breaks because of corrosion fatigue (Figure III-4 and Figure III-5).

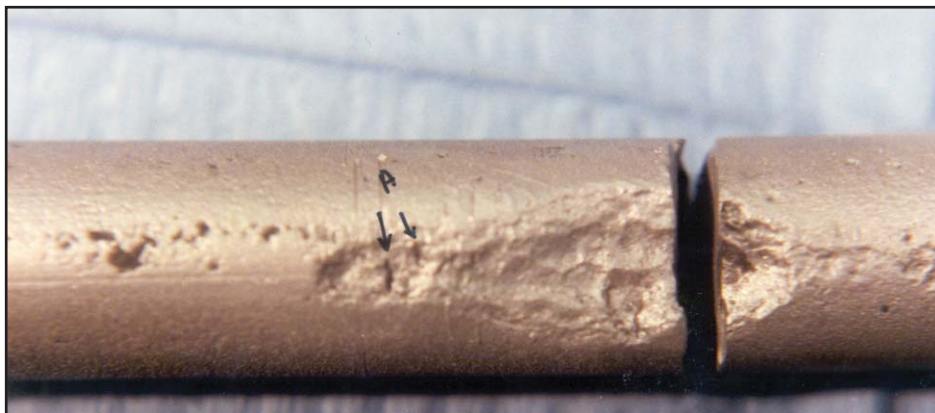
Figure III-6: Sulfide Stress Cracking

Sulfide stress cracking occurs when H_2S corrosion is accelerated by stresses (Figure III-6).

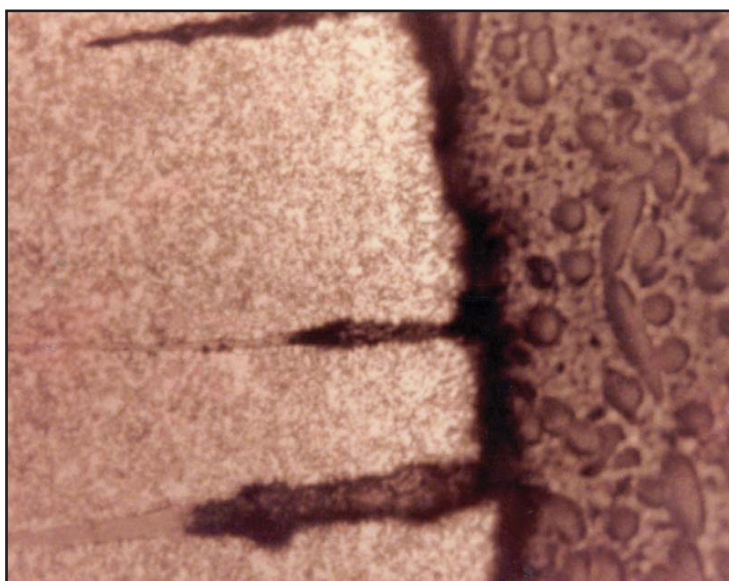
Figure III-9: Stress Cracks

A cross-section shows how deep the cracking can propagate into the metal, with a very small opening (Figure III-8 and Figure III-9).

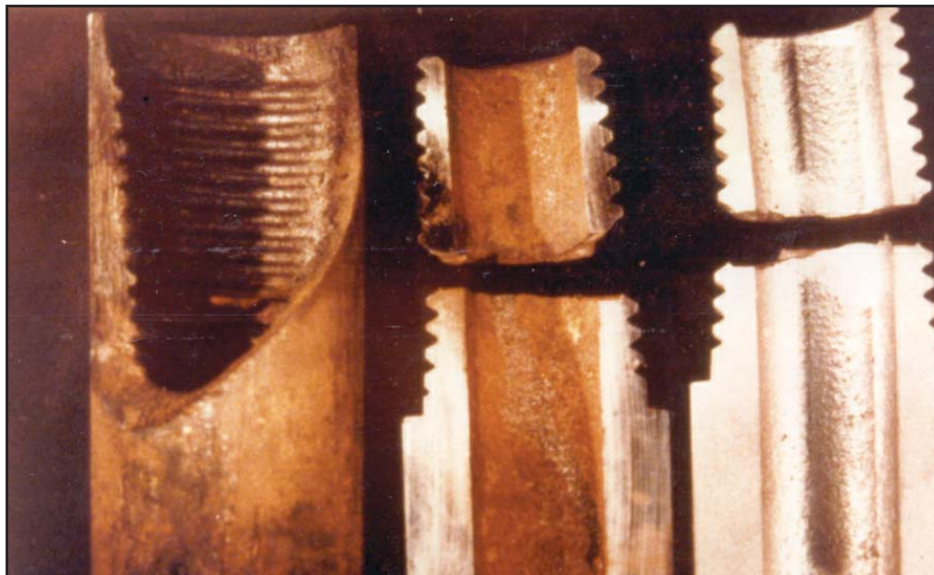
Figure III-10: A Failure Caused by Sulfide Stress Cracking of a Kill String

An unusual instance of sulfide stress cracking occurred with H_2S in a kill string. During acidizing, the ends of the kill string cracked where the connectors were hardened. The field used brine, which contained H_2S , with the acid. The acid inhibitor was not effective, and all the joints cracked (Figure III-10).

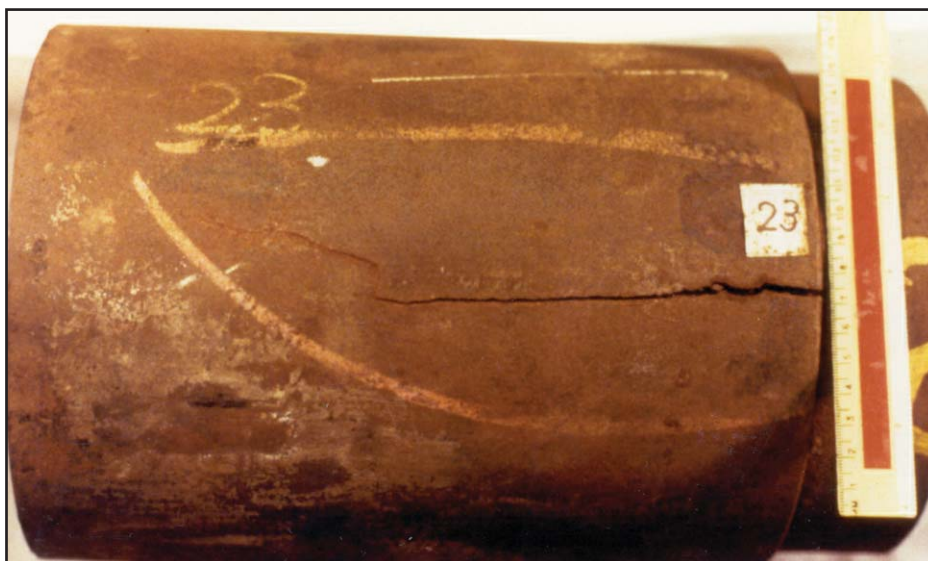
Figure III-12: Hydrogen Embrittlement

Hydrogen, either from the corrosion process or during manufacture, can enter the metal and concentrate internally in high-stress areas, making the steel extremely brittle. Hydrogen embrittlement fractures are catastrophic because very little metal loss occurs before the break. Figure III-12 is an example of hydrogen embrittlement of a drill collar.

Another occurrence of failures with high strength steel is hydrogen induced cracking (HIC), also known as step-wise cracking. In low strength steels, HIC can occur in wet, sour environments. Figure III-12 shows a cross-section of a pressure vessel plate with cracking initiated at an inclusion site. A related type of failure is stress-oriented hydrogen induced cracking (SOHIC). SOHIC occurs in tanks around welded outlets in corrosive service when the welds are highly stressed.

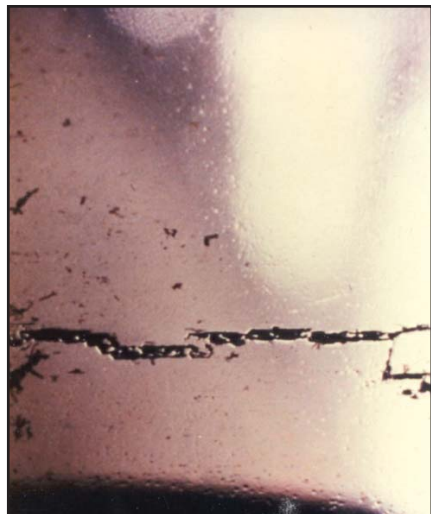
Figure III-13: Chloride Stress Corrosion in Stainless Steel

Austenitic stainless steels such as SS 304 and SS 316 are susceptible to chloride stress cracking in hot aqueous chloride-containing environments. An SS 304 flowline handling a chloride-containing brine cracked at the highly stressed threaded areas (Figure III-13).

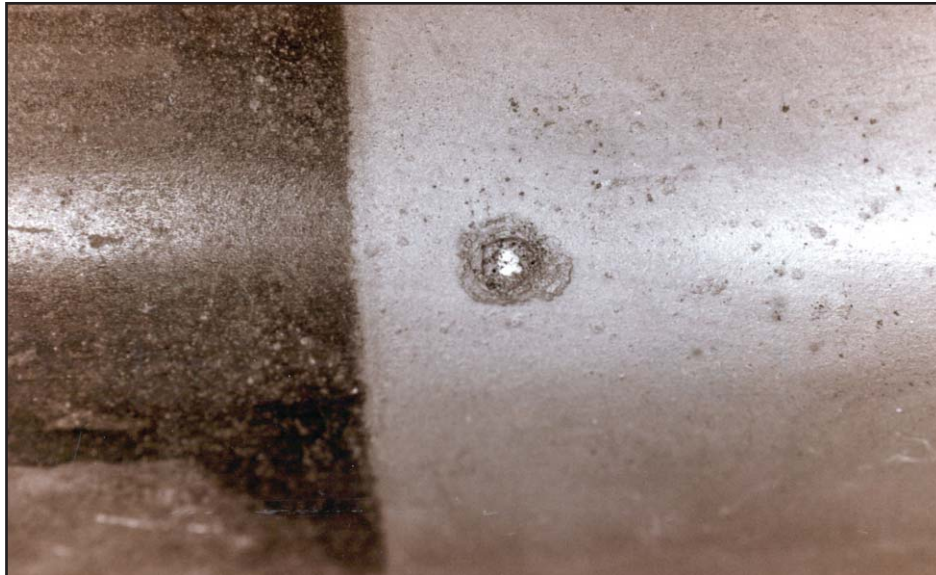
Figure IV-1: Microorganism Influenced Corrosion

Another facet of corrosion is microorganism influenced corrosion (MIC) (Figure IV-1).

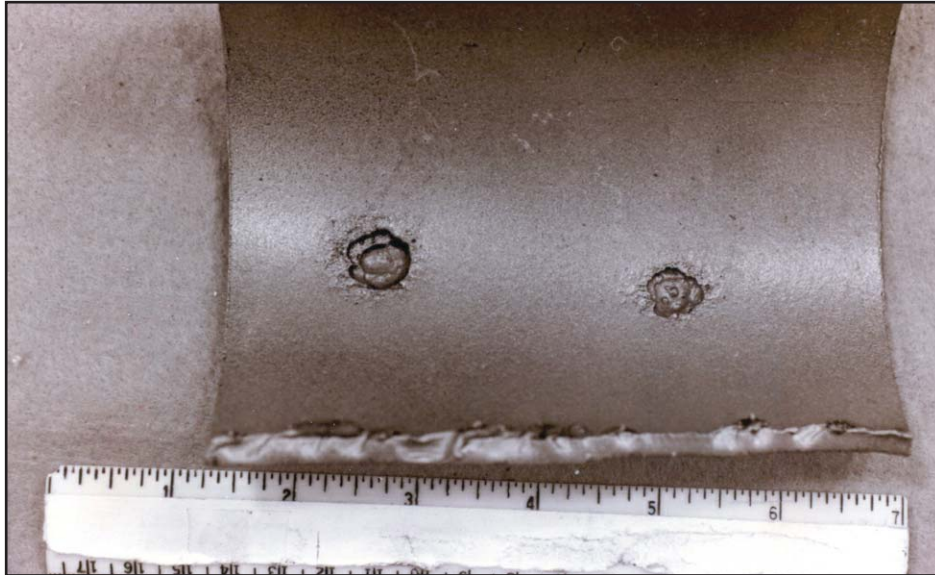
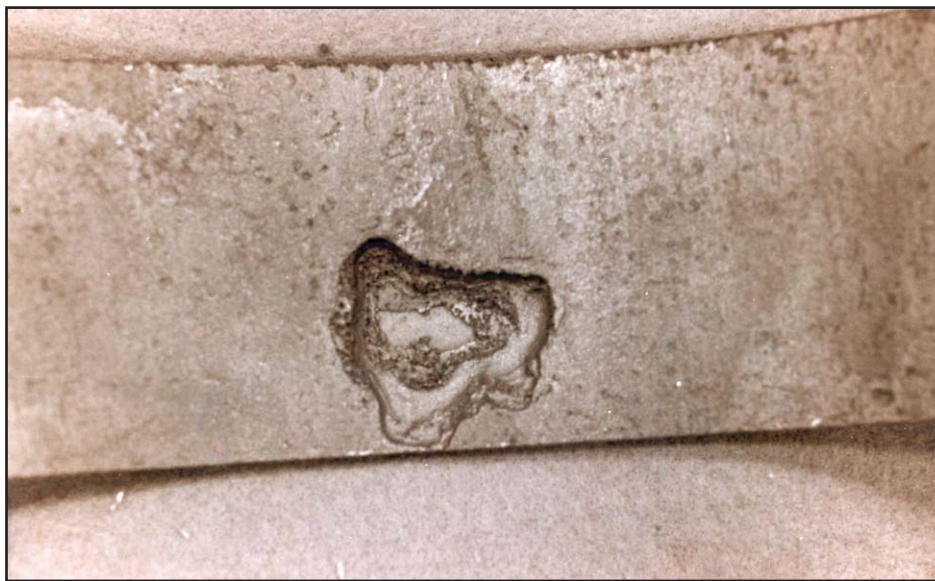
MIC occurs under bacterial growths and the exact mechanism is still open to discussion. In some cases, the bacteria produce acids, which cause the corrosion. In other cases with SRB, H_2S is produced, which can cause H_2S corrosion. With CO_2 , some typical CO_2 attacking can occur because of the breakdown of the film by the bacteria. Bacterial attack is usually characterized by rounded pits with etched sides, edges, and bottoms (Figure IV-2 and Figure IV-3).

Figure IV-2: Bacterial Attack Characteristics

Figure IV-3: Bacterial Attack Characteristics

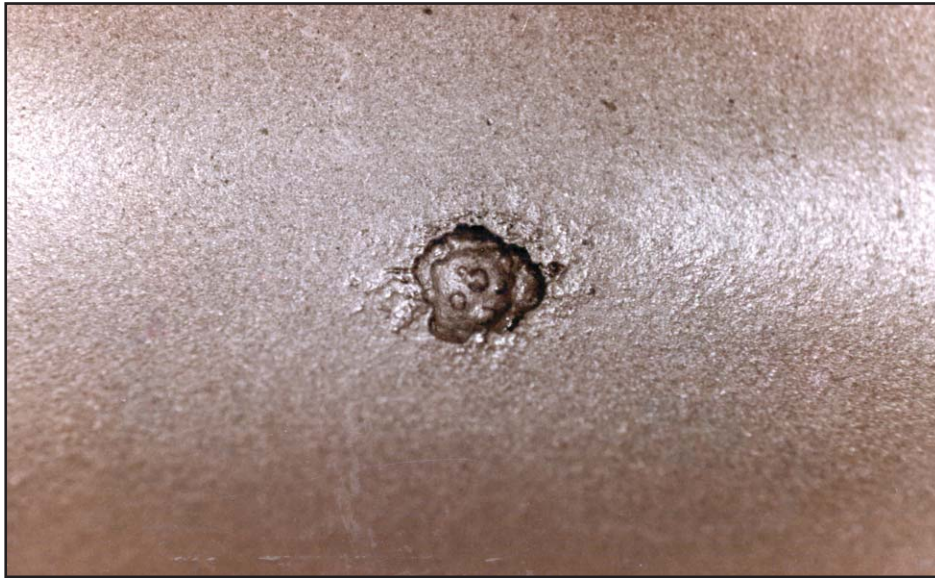
Figure IV-4: The Terraced Effect

At times, the pits have a terraced effect (Figure IV-4 and Figure IV-5).

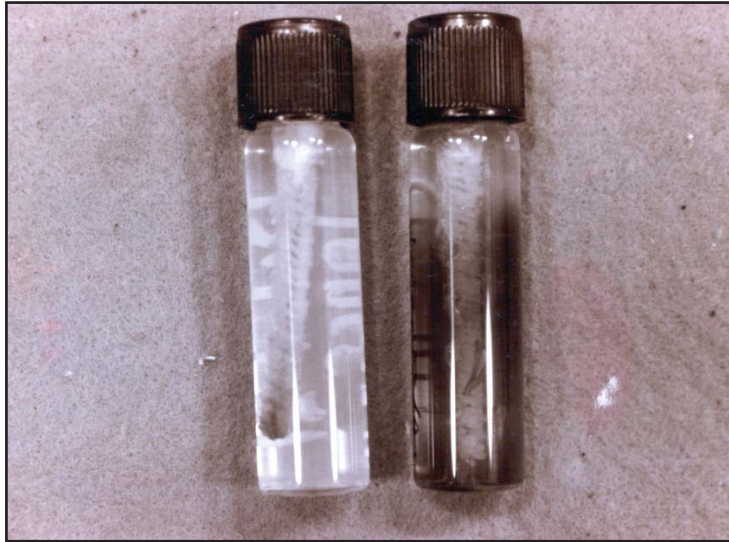
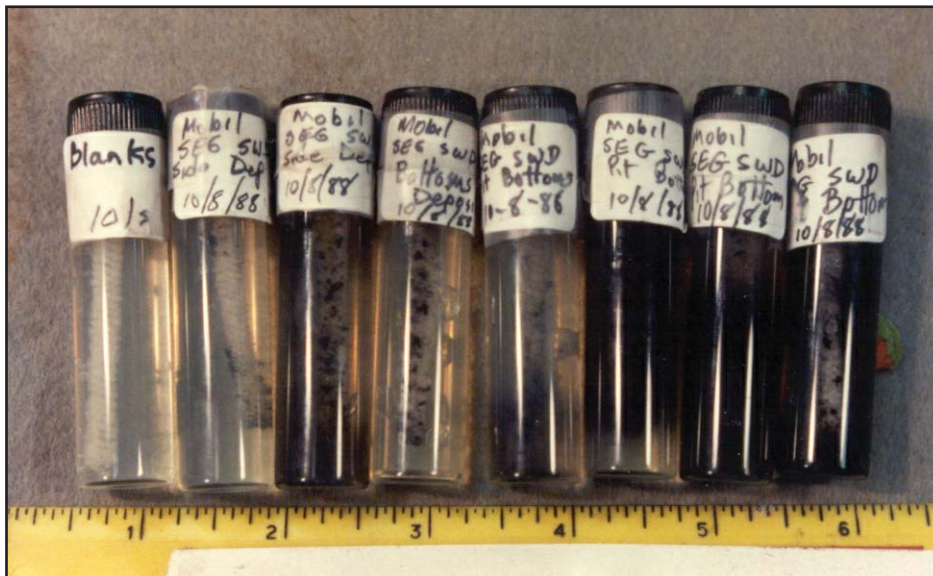
One of the quick tests that can be run for SRB is the pipe cleaner test. Examples with positive results for the pipe cleaner test are shown in Figure IV-6 and Figure IV-7.

Figure IV-6: Pipe Cleaner Test Example

Figure IV-7: Pipe Cleaner Test Examples

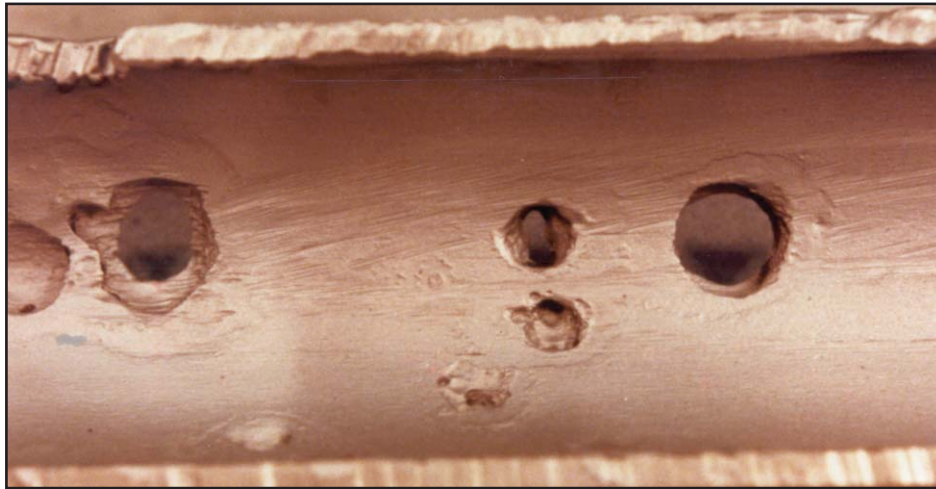
Figure IV-8: MIC Attack in Conjunction with CO₂ Attack

Other examples of MIC attack in conjunction with CO₂ are shown in Figure IV-8.
